11 Preservation Briefs

National Park Service
U.S. Department of the Interior

Rehabilitating Historic Storefronts

H. Ward Jandl

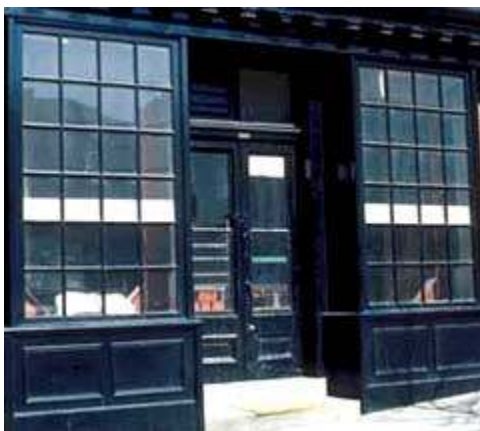
This cast iron storefront from the late 19th century has been well maintained over the years. Photo: NPS files.

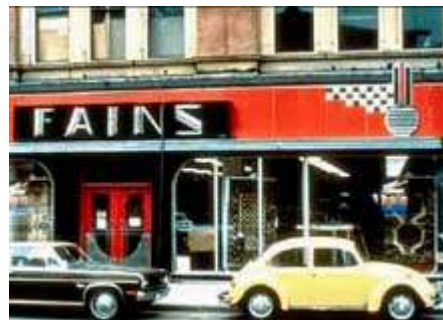
This 1930s Moderne storefront has gained significance over time and should be preserved. Photo: NPS files.

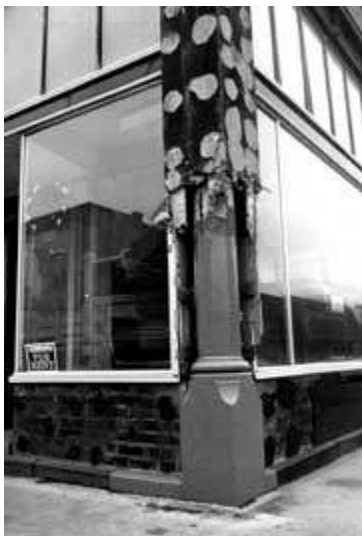
Storefronts of the 1940s, 50s, and 60s were frequently installed by attaching studs or a metal grid over an early front and applying new covering materials. Photo: Bob Dunn.

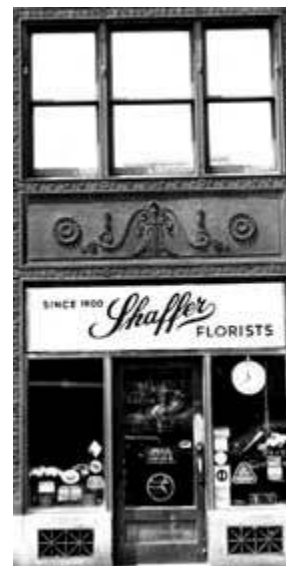
This finely detailed bronze storefront is typical of many constructed during the 1920s. The original grilles, spandrel panel and windows are all intact. Photo: NPS files.

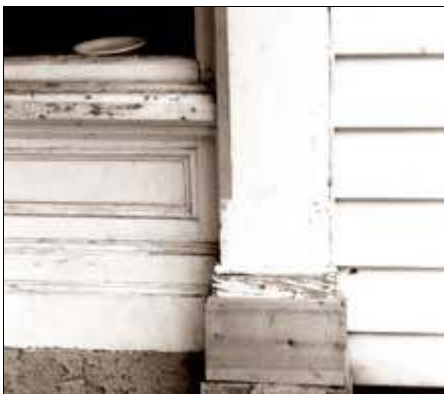
Rather than replace an entire wooden storefront, a new wooden component can be pieced-in, as seen in this column base. Photo: NPS files.

Where components of wood storefronts are so badly deteriorated that they cannot be stabilized, it is possible to replace the deteriorated parts with new pieces. These techniques all require skill and some expense, but are recommended in cases where decorative elements, such as brackets or pilasters, are involved. In some cases, missing edges can be filled and rebuilt using wood putty or epoxy compounds. When the epoxy cures, it can be sanded smooth and painted to achieve a durable and waterproof repair.

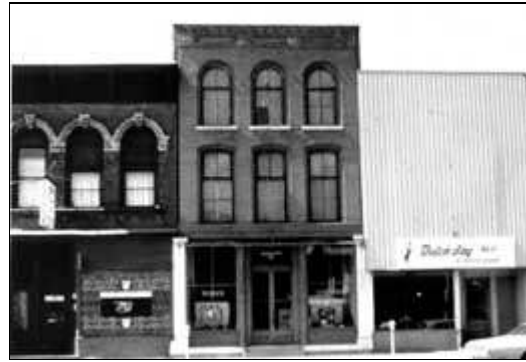
This photograph shows the impact of preserving historic storefronts. The one on the right has been totally obscured by a "modern" front added in the 1950s. Photo: NPS files.

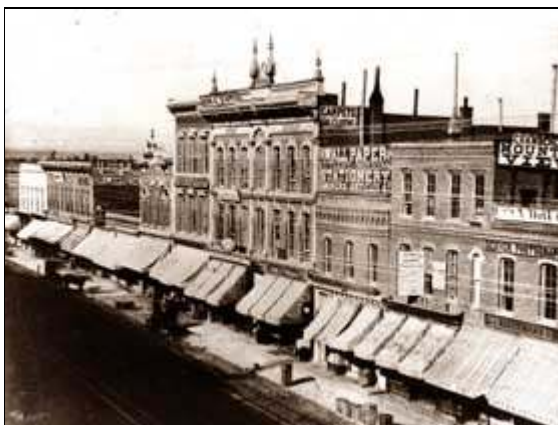
Try to locate old photographs or prints to determine what alterations have been made to the storefront and when they were undertaken. Awnings were common elements of storefronts at the turn of the century. Photo: NPS files.
